**Flood Control Project Maintenance  
Levee Inspections**

**Maintenance Issue Types Only, Levee Inspection Report By Mile - Fall 2018**

**Sacramento River West Side Levee District**

Waterway	Bank	Unit Miles	Inspection Start/End	Inspector
Unit No. 01 Sacramento River	Right	49.64	10/10/2018 10/10/2018	Zach Jojola

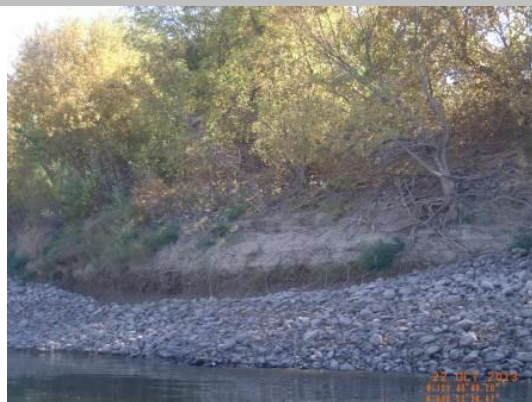
Photo 1 of 1 : FA\_2018\_NA0016\_435\_84\_20181023\_00019.jpg

LM Start	11.50	Rating **	M	Issue No.	84
LM End	11.53	Issue Type +	Ma	Location *	WS
Category	Supplemental			GPS Latitude/Longitude	
				Start	End
Item	2017 USACE Erosion Survey, DRAFT			38.874854 °	38.875109 °
				-121.813018 °	-121.813592 °
DWR ID	DWR_NA0016_01_f_2018_84				
Comment Code					
Inspector Comment					
2017 Site ID: SAC 101.3 R					
Status: Eroding					
2017 Field Notes: No observed change..					
Site History: 1997 - Toe damage and loss of cobble revetment and small patch of local damage to the cobble revetment. 2000 - Cohesive vertical toe; revegetation site.

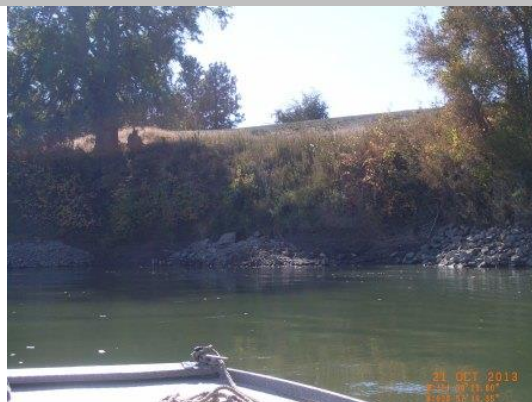
Photo 1 of 1 : FA\_2018\_NA0016\_435\_85\_20181023\_00230.jpg

LM Start	18.76	Rating **	A/W	Issue No.	85
LM End	18.78	Issue Type +	Ma	Location *	WS
Category	Supplemental			GPS Latitude/Longitude	
				Start	End
Item	2017 USACE Erosion Survey, DRAFT			38.954060 °	38.954312 °
				-121.840560 °	-121.840774 °
DWR ID	DWR_NA0016_01_f_2018_85				
Comment Code					
Inspector Comment					
2017 Site ID: SAC 111.0 R					
Status: Eroding					
2017 Field Notes: No observed change.					
Site History: 2009 - Minor erosion, should be repaired under maintenance. 2011 - Some new minor erosion at the toe.

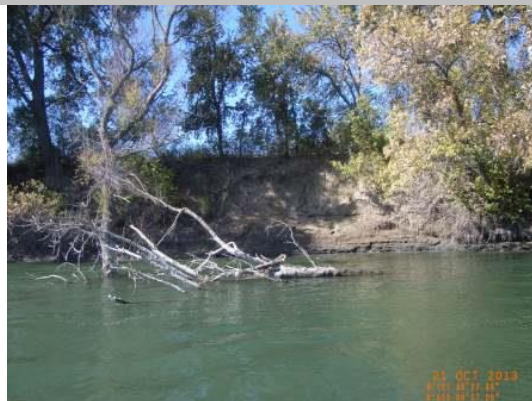
Photo 1 of 1 : FA\_2018\_NA0016\_435\_88\_20181023\_00232.jpg

LM Start	25.75	Rating **	A/W	Issue No.	88
LM End	25.91	Issue Type +	Ma	Location *	WS
Category	Supplemental			GPS Latitude/Longitude	
				Start	End
Item	2017 USACE Erosion Survey, DRAFT			39.014499 °	39.016401 °
				-121.825880 °	-121.824230 °
DWR ID	DWR_NA0016_01_f_2018_88				
Comment Code					
Inspector Comment					
2017 Site ID: SAC 118.0 R					
Status: Eroding					
2017 Field Notes: No observed change.					
Site History: 2008 - Whole bank is eroding, nearly vertical slope with cohesive toe. Bed is very deep along the toe (greater than 30 ft deep at 20 ft from the shore). 2011 - Some new minor erosion. 2016 - Minor new erosion.

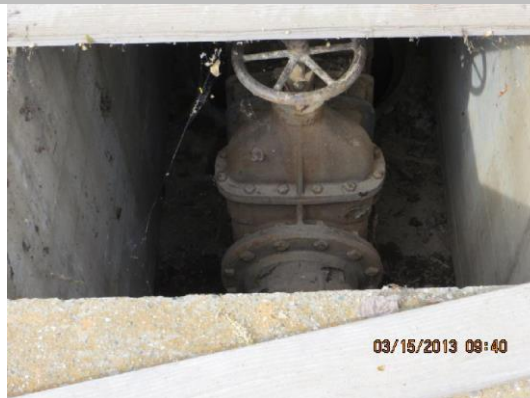
Photo 1 of 3 : UCIP\_FA\_2018\_10306\_17566.jpg

Comment Code						
Inspector Comment						
FS_ID:10306						
DS_ID:20341						
EP_NO: 9358						
Repair Type: No Action Needed						
Crossing Status: Found						
UCIP Comments:						
FIELD_STRUCT_DESC: 16-inch steel drainage pipe through the levee, 8.5 feet below the crown. Siphon breaker inside a 24-inch corrugated metal riser unit on the waterside (WS) slope. Pump inside pump house on the landside (LS). Overhead power line crosses the levee. Pole on the LS shoulder. (one 12-inch, one 16-inch, and one 24-inch pipes [HLM 29.02] authorized under Automatic Board Order (ABO) issued as Permit No. 9358, 1974 - Crocker National Bank (Trustee)). [Additional Reference(s): DWR Levee Log, 2006. USACE Sacramento O&M Manual 131, May 1960 (HLM 29.02)].						
FS Date: 3/15/2013

Gate valve under pumphouse on LS toe.

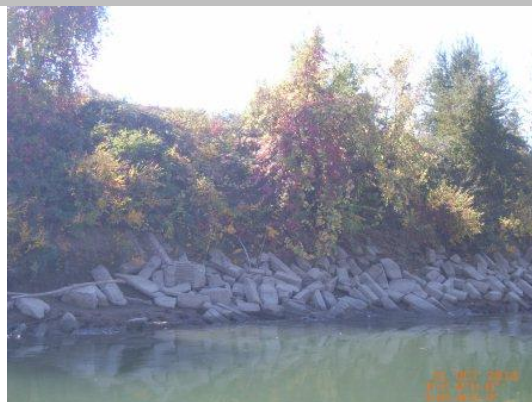
Photo 1 of 1 : FA\_2018\_NA0016\_435\_92\_20181023\_00235.jpg

LM Start	31.43	Rating **	A/W	Issue No.	92
LM End	31.45	Issue Type +	Ma	Location *	WS
Category	Supplemental			GPS Latitude/Longitude	
				Start	End
Item	2017 USACE Erosion Survey, DRAFT			39.067004 °	39.066901 °
				-121.866913 °	-121.867322 °
DWR ID	DWR_NA0016_01_f_2018_92				
Comment Code					
Inspector Comment					
2017 Site ID: SAC 123.7 R Status: Eroding 2017 Field Notes: No observed change. Site History: 1997 - Erosion into the levee section; old concrete rubble loss at toe; transition between the rock upstream and the cobble downstream. 2000 - Cohesive bench with concrete slabs on top; 25 ft deep scour hole on the downstream end.					
DWR Inspector Comment: Appears to be stable. Plenty of berm and cobble left.

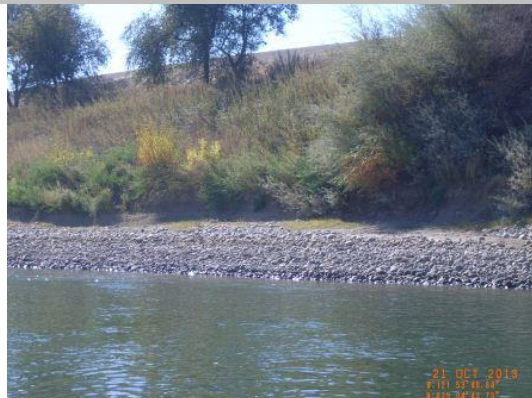
Photo 1 of 1 : FA\_2018\_NA0016\_435\_93\_20181023\_00236.jpg

LM Start	33.29	Rating **	A/W	Issue No.	93
LM End	33.37	Issue Type +	Ma	Location *	WS
Category	Supplemental			GPS Latitude/Longitude	
				Start	End
Item	2017 USACE Erosion Survey, DRAFT			39.078340 °	39.079351 °
				-121.894656 °	-121.895317 °
DWR ID	DWR_NA0016_01_f_2018_93				
Comment Code					
Inspector Comment					
2017 Site ID: SAC 125.6 R					
Status: Eroding					
2017 Field Notes: No observed change.					
Site History: 2008 - Slow erosion of the hard toe. 2010 - Cobble rubble is failing, erosion is into the toe of the levee, with vertical slumping.					
2012 - Site appears to be relatively stable. 2013 - New animal holes.

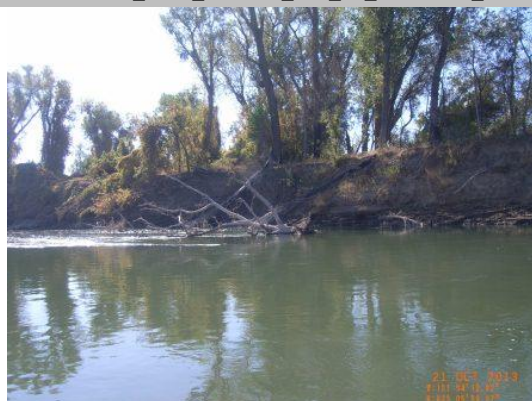
Photo 1 of 1 : FA\_2018\_NA0016\_435\_94\_20181023\_00237.jpg

LM Start	35.23	Rating **	A/W	Issue No.	94
LM End	35.33	Issue Type +	Ma	Location *	WS
Category	Supplemental			GPS Latitude/Longitude	
				Start	End
Item	2017 USACE Erosion Survey, DRAFT			39.099482 °	39.100836 °
				-121.903430 °	-121.904320 °
DWR ID	DWR_NA0016_01_f_2018_94				
Comment Code					
Inspector Comment					
2017 Site ID: SAC 127.9 R					
Status: Eroding					
2017 Field Notes: fresh erosion at lower slope.					
Site History: 1997 - Major scour off the downstream end of existing rock, creating a scour pocket where the levee starts diverging from the bankline. 2000 - Some minor erosion, 20 ft deep hole at downstream end. 2004 - Small amount of new erosion. 2010 - Bad transition off downstream end of rock revetment, some new erosion. 2012 - Site extended downstream, minor new erosion. 2013- Minor new erosion. 2016 - Fresh erosion at toe.

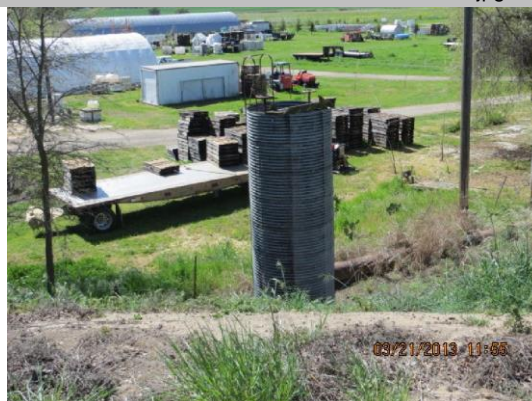
Photo 2 of 3 : UCIP\_FA\_2018\_10535\_17876.jpg

Item	DWR UCIP LMA Responsibility			39.152347 °		39.152347 °
				-121.920610 °		-121.920610 °
DWR ID	20288					
Comment Code						
Inspector Comment						
FS_ID:10535 DS_ID:20288 EP_NO: N/A Repair Type: No Action Needed Crossing Status: Found UCIP Comments: FIELD_STRUCT_DESC: 24-inch drainage pipe of an unknown material through the levee, 19 feet below the crown. 6-foot diameter corrugated metal standpipe on the landside (LS) toe. Pump and 24-inch pipe on the LS. Slide gate in corrugated metal riser unit on waterside (WS) slope. Concrete block wall at WS toe for discharge line. (Modified under Permit No. 8587, 1973 - Anthony E. Steidlmayer). [Additional Reference(s): DWR Levee Log, 2006. USACE Sacramento O&M Manual 131, May 1960 (HLM 41.56)]. FS Date: 3/21/2013

6-foot diameter CMP riser with slide gates on LS toe.

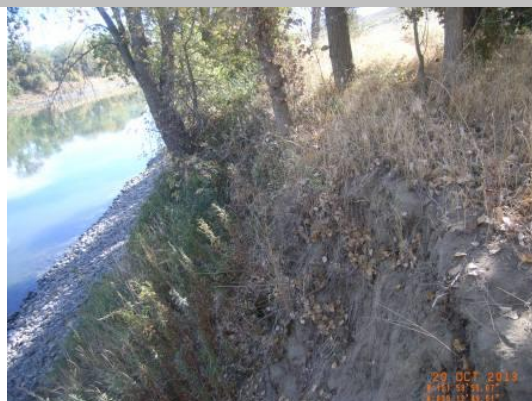
Photo 1 of 1 : FA\_2018\_NA0016\_435\_105\_20181023\_00240.jpg

LM Start	49.46	Rating **	A/W	Issue No.	105
LM End	49.57	Issue Type +	Ma	Location *	WS
Category	Supplemental			GPS Latitude/Longitude	
				Start	End
Item	2017 USACE Erosion Survey, DRAFT			39.213608 °	39.213869 °
				-121.997543 °	-121.999641 °
DWR ID	DWR_NA0016_01_f_2018_105				
Comment Code					
Inspector Comment					
2017 Site ID: SAC 143.5 R					
Status: Eroding					
2017 Field Notes: New erosion along lower slope.					
Site History: 2011 - Multiple scallops, one tree pop out. Old cobble site starting to unravel at midbank. 2012 - Mid bank slumping continues to worsen but cobble at the toe appears stable.					
DWR Inspector Comment: Erosion on the waterside berm. Recommend monitoring.
